## TECHNICAL INSPECTION REPORT

### 6 OPERATION CROSSROADS. U.S.S. CRITTENDEN (APA77)

TEST ABLE.

OPERATION CROSSROADS

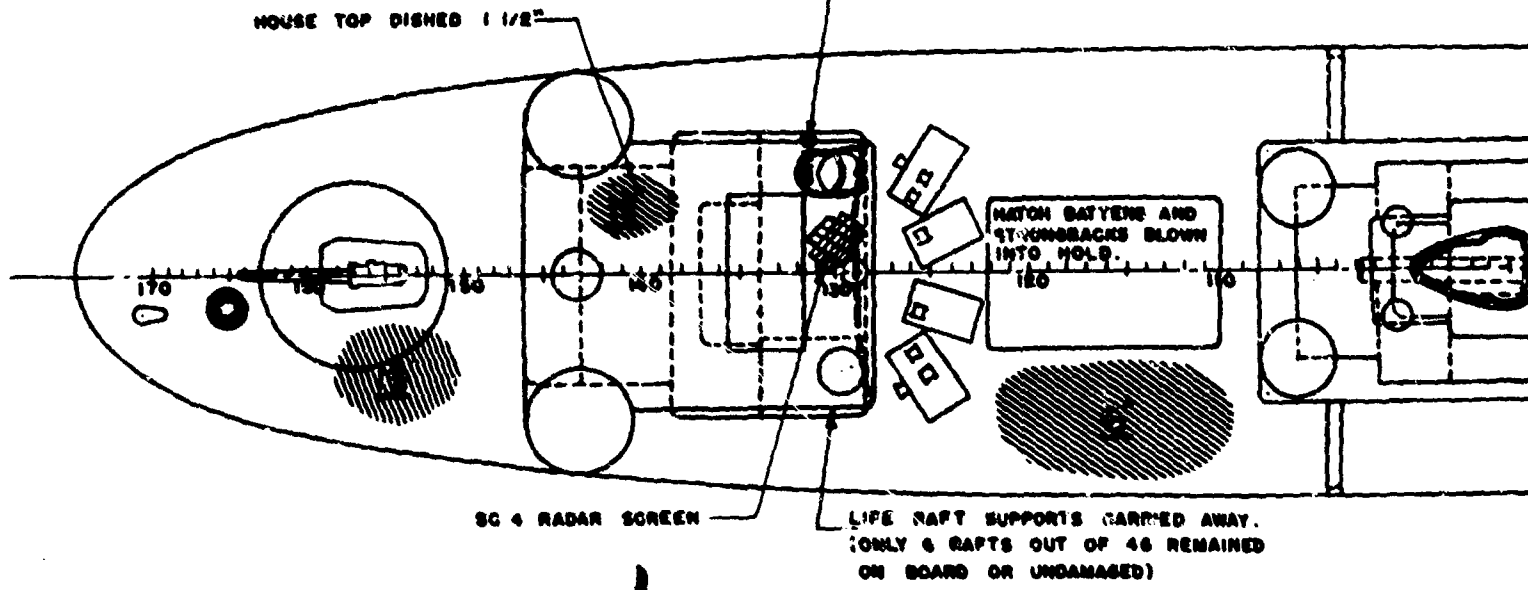
HOUSE TOP BUCKLED DOWN 6" FROM PRESSURE  
EXERTED BY DIRECTOR TUB FOUNDATION

SC 4 RADAR SCREEN FELL TO TOP  
OF AFTER DECK HOUSE
